Technical Report 1730-TR

DEMOLITION OF CONCRETE LOCKS ON THE OHIO RIVER
(RESEARCH PHASE)

Project 8F07-10-002

U S Army
Engineer Research And
Development Laboratories

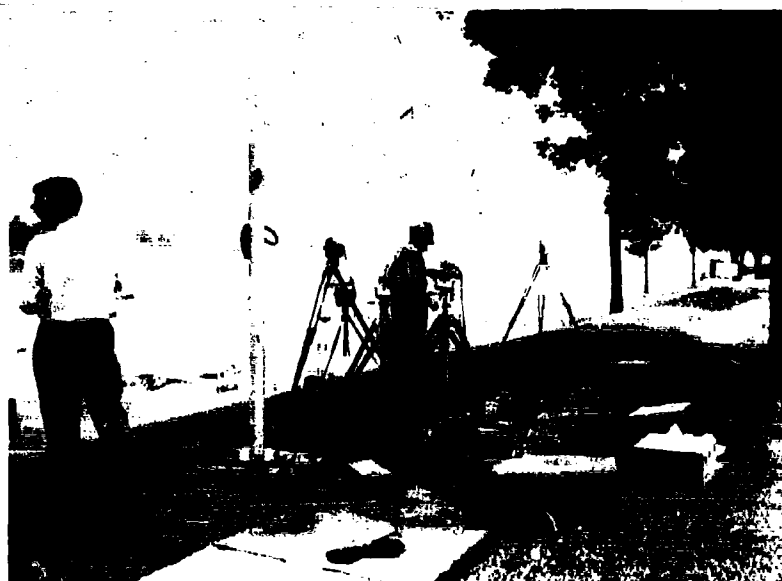
H7742
Fig. 2. Photographic equipment for recording tests on upper guide wall of Lock 29.

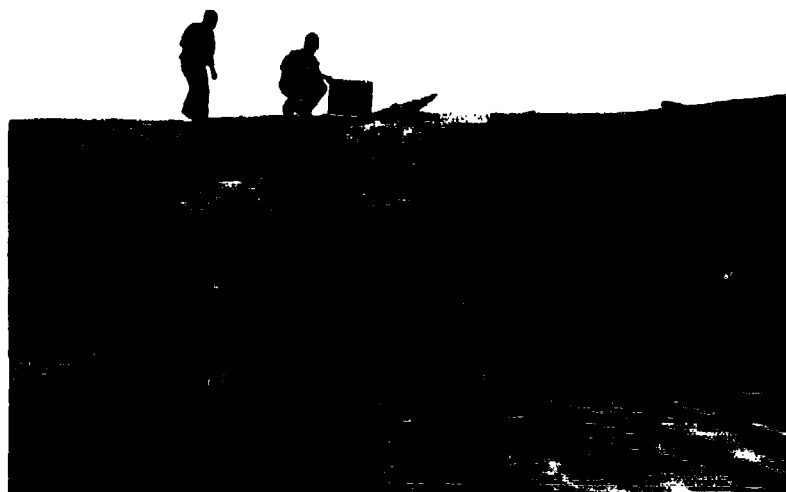
Fig. 4. Crater produced by 50-pound charge on charge side of wall (top) and spall produced on side of wall opposite 50-pound charge (bottom).

b. Results. The first 50-pound charge produced a clear breach of the wall. The crater was 82 inches wide and 55 inches high. The spall was 187 inches wide by 82 inches high (Fig. 4). The second 50-pound charge did not quite breach the wall. The crater was $20\frac{1}{2}$ inches deep by $93\frac{1}{2}$ inches wide by 59 inches high, and the spall was 26 inches deep by 166 inches wide by $61\frac{1}{2}$ inches high.

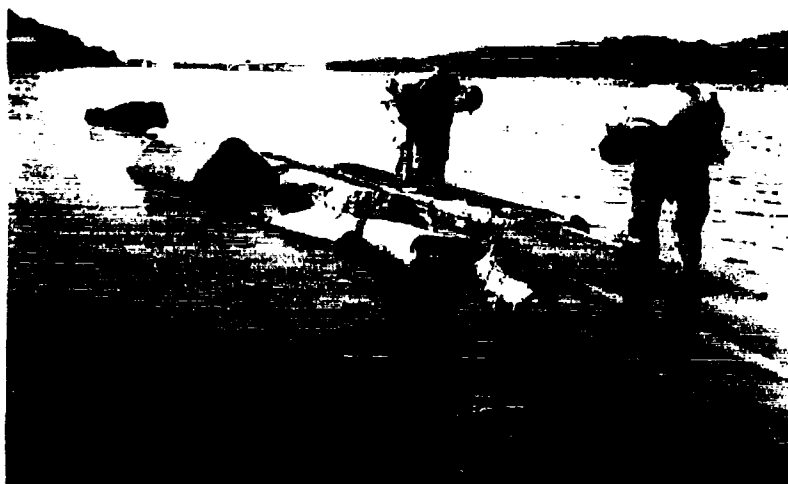
Fig. 17. Concrete toppled back into water by 40-pound charge placed 5 feet under water.

broke off about 10 feet of concrete 4 to 5 feet deep and toppled it back into the water behind the charge (Fig. 17). The next 30-pound charge produced a clean breach but did not topple the wall. The wall was pushed back, however, and a portion of the wall was spalled out from the top rear down as far as could be probed in the silt behind the wall (Fig. 18).

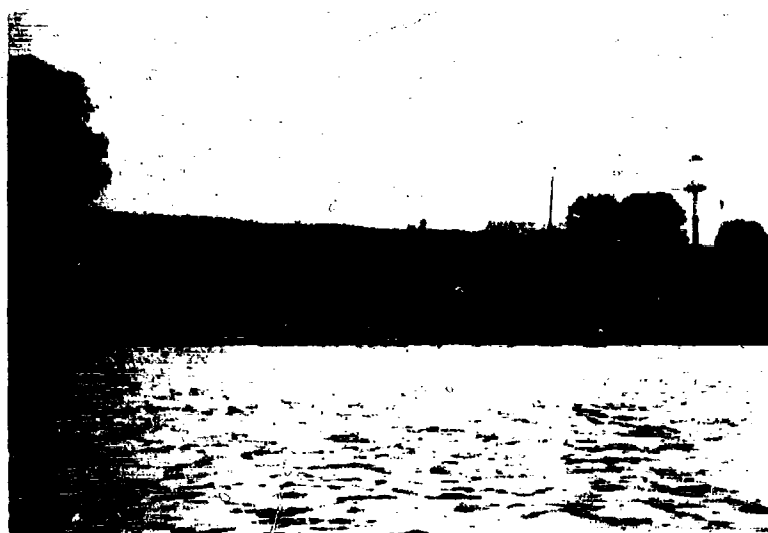
Fig. 22. Crater produced by two 40-pound charges placed 4 feet under water, 26 feet apart, and fired at approximately same instant (top); and spall produced by same two charges (bottom).

The two 40-pound charges, spaced 26 feet apart and fired at approximately the same time, produced a continuous breach 36 feet long. Damage continued beyond the full breach for another 10 feet at each end. The height of the breach appeared to be about 5 feet (Fig. 22).

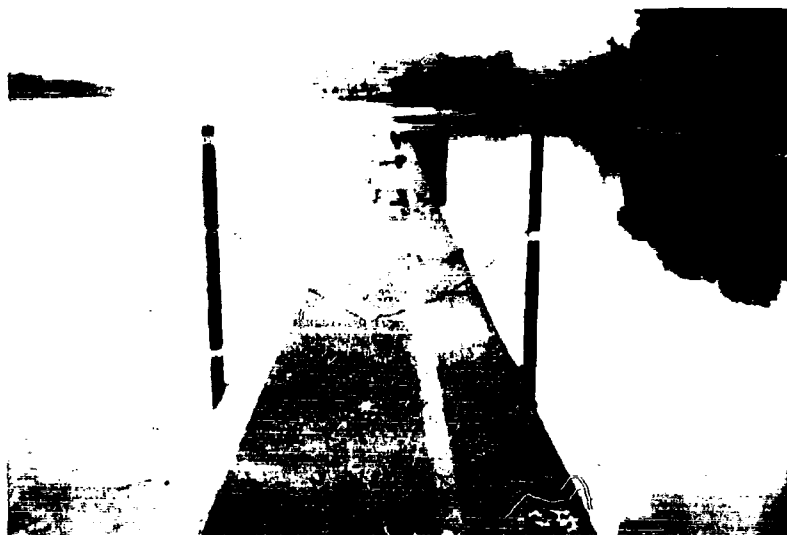
Fig. 24. Underwater opposed charges prepared for simultaneous detonation.
